**Innovative Masking of Ferrous Inserts in Magnesium
Aerospace Components Prior to Tagnite Anodization
(v.1, Unlimited Release)**

ARL-CR-716

July 2013

**Technology Applications Group, Inc.
810 S. 48th St.
Grand Forks, ND 58201**

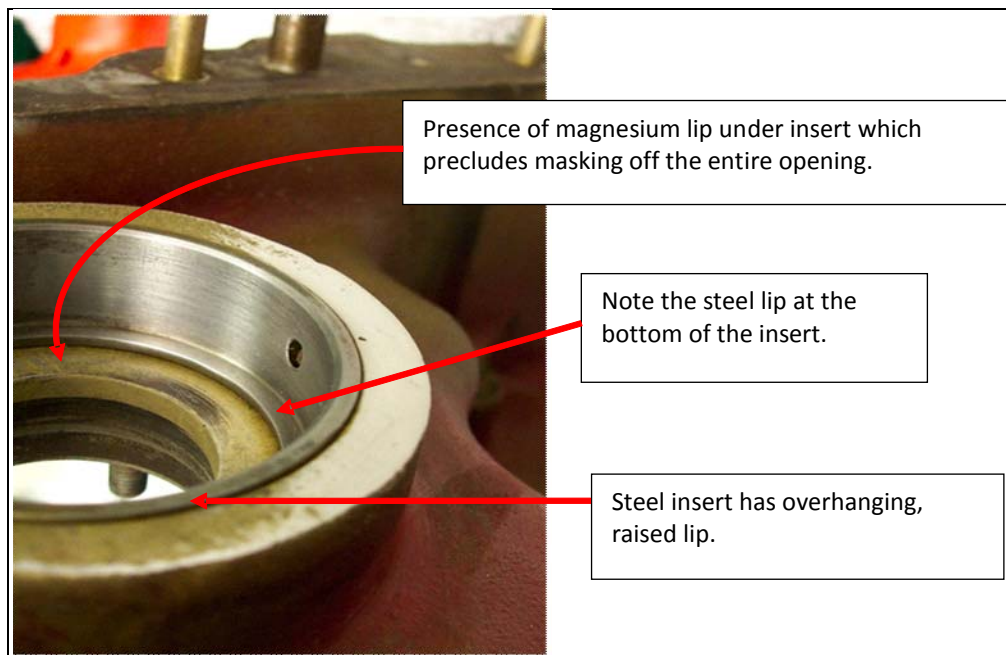
Figure 5 (an accessory cover) illustrates the problem with developing masking tools. The steel bushings are smooth with large through holes, therefore there is no convenient place to attach masking tools. In addition, a small steel lip that overhangs the magnesium poses another masking dilemma.

Figure 5. Typical problems encountered when masking typical steel liner-type inserts.

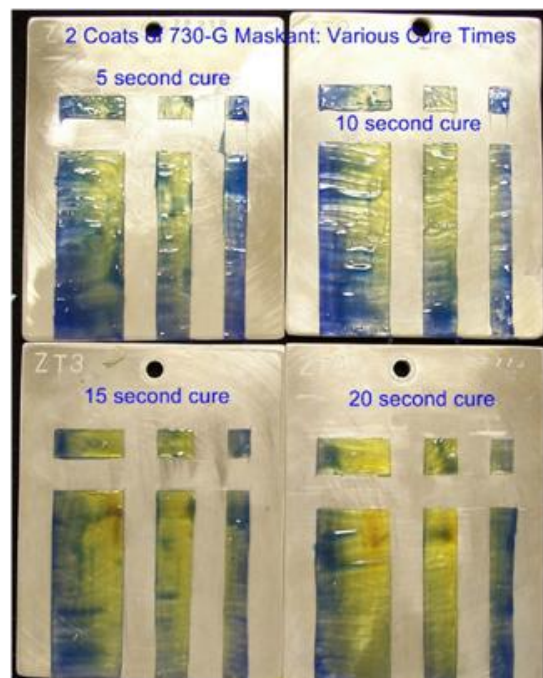
In figure 10, the cure was tested by pressing a finger into the cured maskant. If the finger sticks to the maskant, the cure is incomplete. The cure was then checked for maskant adhesion around the edges. If lifting is present, the cure is incomplete.

Figure 10. Two coats of 730-BT maskant after various cure times.

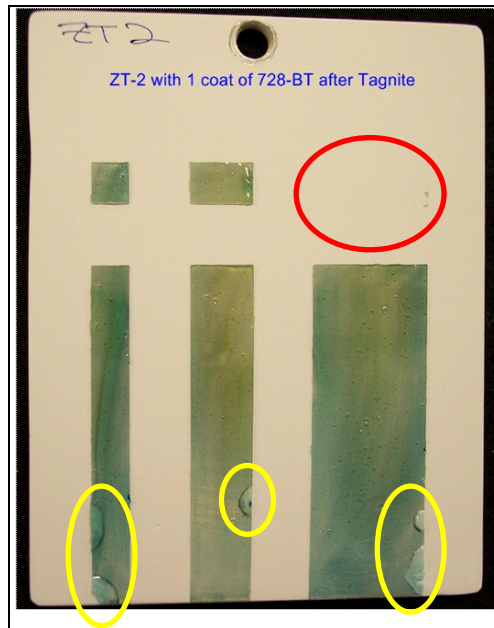
Figure 11. Panel with one coat of 728-G. Red shows area where maskant lost adhesion during Tagnite process. Yellow shows lifting of maskant after Tagnite.

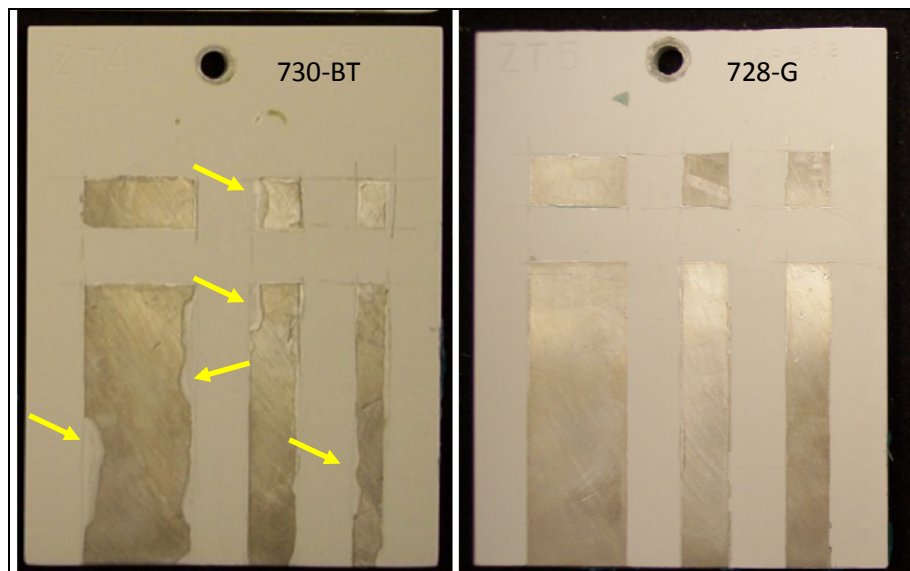
Figure 12. Both panels were placed in fluoride activator for 1 h and were Tagnite coated for 12 min at $9A/ft^2$. Left: 730-BT maskant had significant lifting (yellow arrows) during the Tagnite process. Right: 728-G maskant remained intact throughout the entire process, leading to well-defined masked areas.

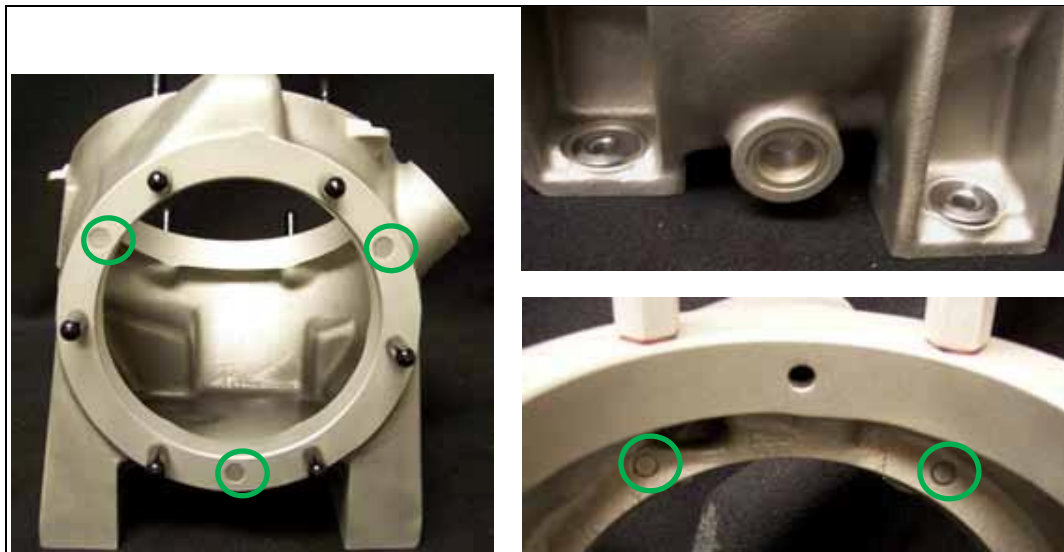
After media blast cleaning, the parts were thoroughly examined, and the mixed metal inserts could be classified into five different categories (figure 17):

Figure 17. Mixed metal types on H-60 magnesium components. Left: threaded studs with black caps and machine face buttons (green). Upper right: mounting pad bushings. Lower right: bottom of studs penetrated through the as-cast surface (green).

The threaded studs were masked using threaded stud covers made from 6061 aluminum along with O-rings. An example of this type of threaded cover is seen in figure 18. The helicoils were masked using threaded 6061 aluminum inserts/O-rings that matched the thread count of the helicoils. These masking tools, developed during prior research, worked very well with these parts.

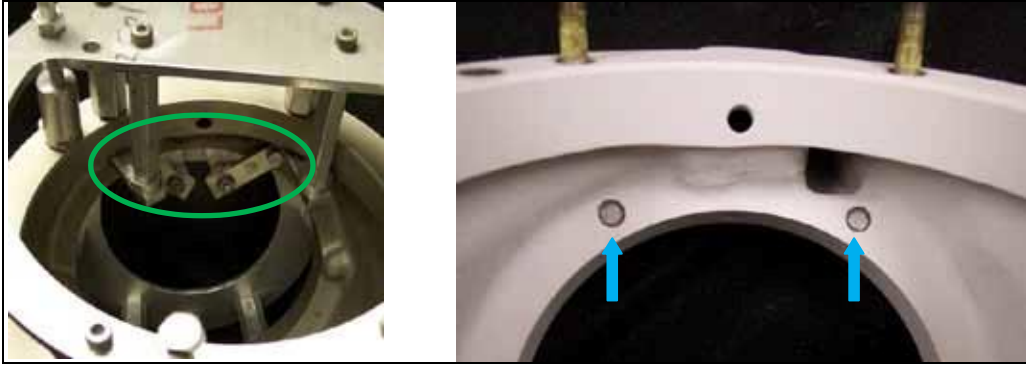
Figure 21. Masking for stud bottoms on H-60 components. Left: masking for stud bottoms using linkage to bridge. Right: close-up of stud bottoms after Tagnite (no damage).

The mounting pad bushings were initially masked using top and bottom covers with O-rings, where the bottom cover threaded into the top cover to provide the necessary seal. Initial attempts at masking these bushings were met with high failure rates due to leakage around the top part of the bushing, as seen in figure 19. The machine face buttons were masked using 6061 aluminum covers with O-rings that were held in place with a bridge attached to the aluminum stud covers (figure 20). The initial masking attempt suffered from minor leakage due to alignment problems with the covers, as seen in figure 20, lower right. The bottom of the studs that penetrated the as-cast surface (figure 17, lower right) were first masked using a matching cover with an O-ring connected by a linkage to the other masking tools, as seen in figure 21. This methodology worked well, but installation was very complicated.

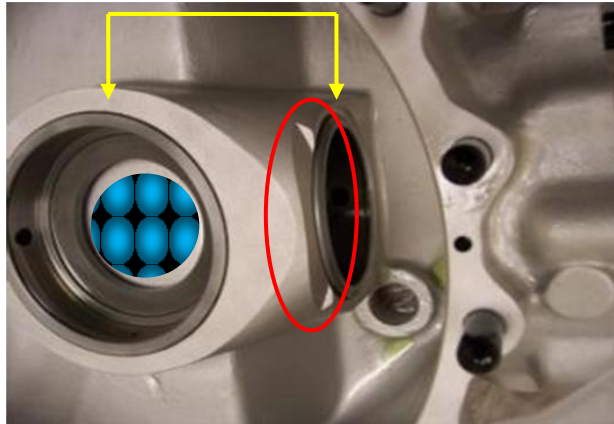
The primary masking challenge on the tail rotor gearbox housing was the masking of the two steel liners inside the housing. The difficulties with these liners were as follows:

1. There was solid magnesium underneath the liners, which eliminates the use of top and bottom covers (figure 34, blue shading).
2. One of the liners had a notch in the magnesium around the perimeter of the steel liner (figure 34, red oval).
3. The steel liners are mounted at a 90° angle to each other (figure 34, yellow).

Figure 34. Tail rotor gearbox housing steel liners.

The masking approach shown in figure 35 used to protect these steel liners was to manufacture aluminum covers and place them over the top of the liners. The covers would be held in place by attaching an aluminum bridge to the threaded stud covers for the studs on the machine faces, then use long aluminum studs anchored in the bridge to hold and seal the aluminum cover into place over the steel liners.

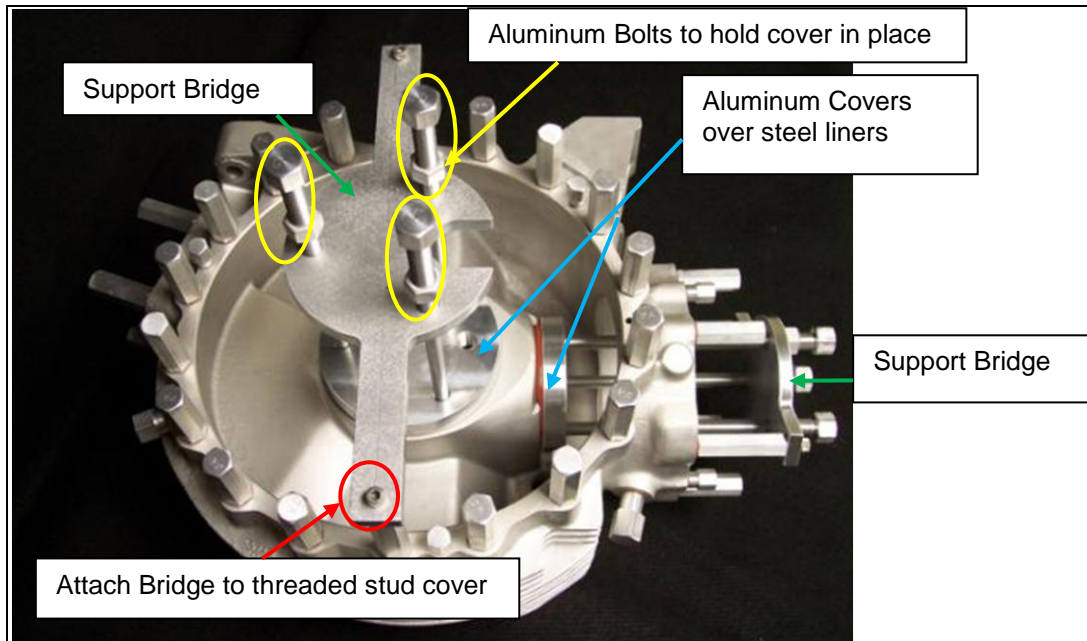
Figure 35. Masking of steel liners on H-64 tail rotor gearbox housing.

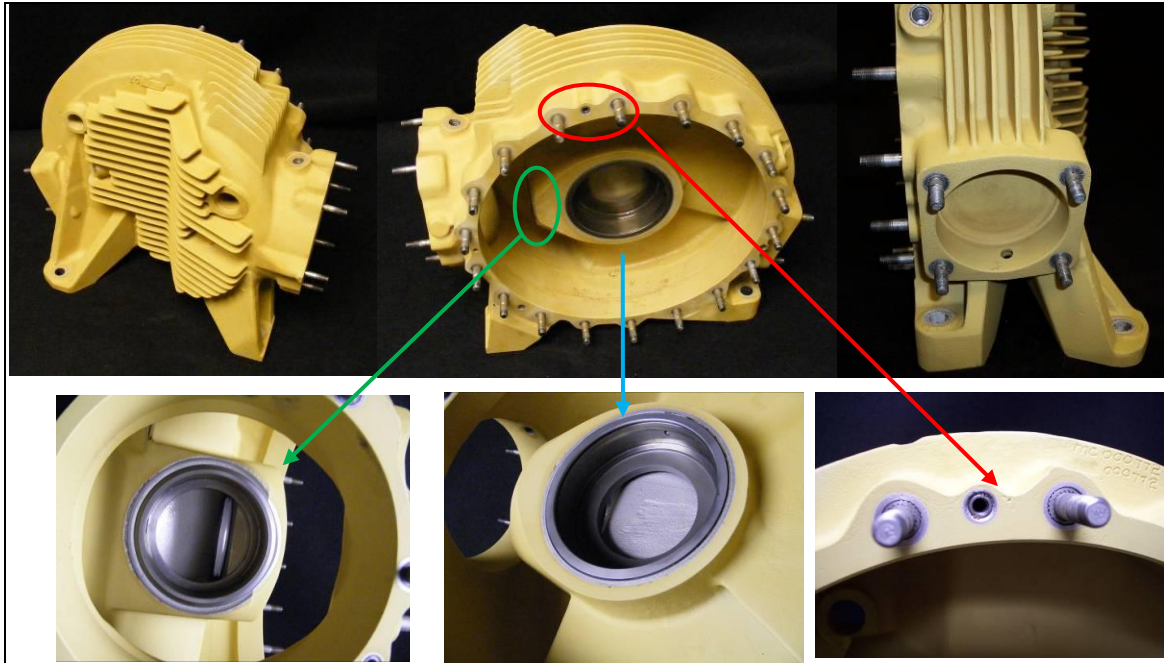
The masked H-64 tail rotor gearbox housings were run through the Immersion Tagnite bath using the same conditions that a new tail rotor gearbox housing without any mixed metal would be processed in the TAG production line. After the immersion Tagnite process, the masking was removed and the parts were inspected. Multiple trials were done using the masking protocol, and there was never a single instance of damage to any mixed metal inserts on this part. Pictures of tail rotor gearbox housings after Tagnite are shown in figure 36.*

Figure 36. H-64 tail rotor gearbox housing after Tagnite 8500.

After Immersion Tagnite and inspection of the mixed metal inserts, the bare areas around the mixed metals were touched up using low-voltage Brush Tagnite (figure 37).

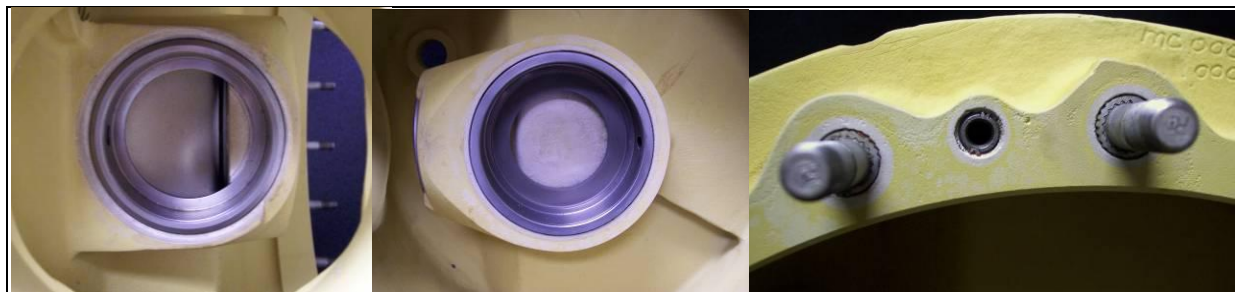
Figure 37. H-64 tail rotor gearbox housing after Brush Tagnite touchup around mixed metal inserts.

Note: Brush Tagnite coating is light gray in appearance.

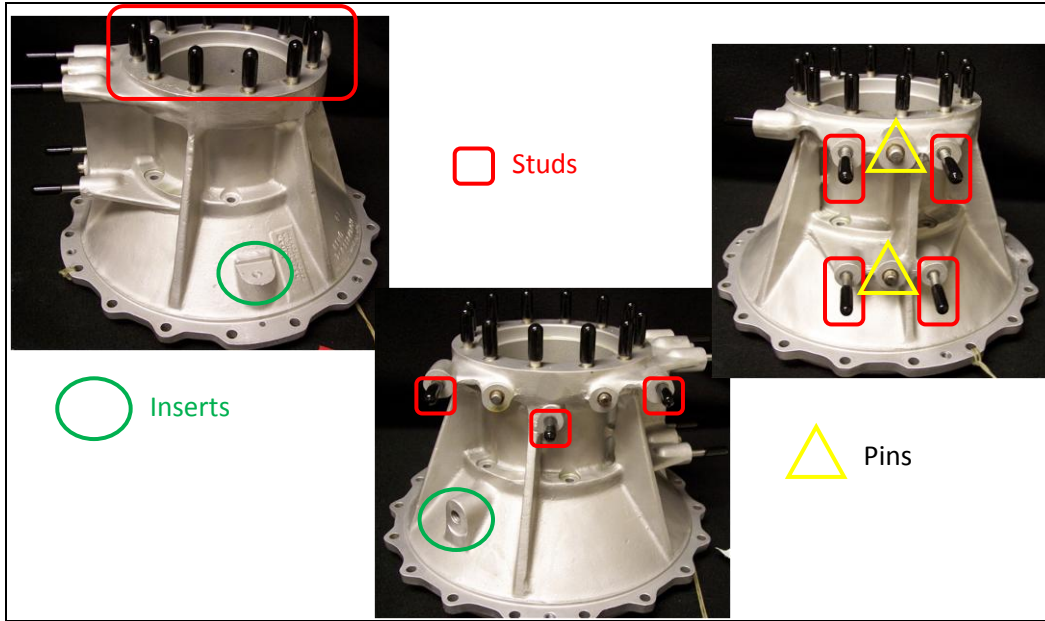
Figure 38. Tail rotor cover contains 12 studs on machine face (left), 7 extended studs (center and right), 2 alignment pins (right), and 2 inserts (left and center).

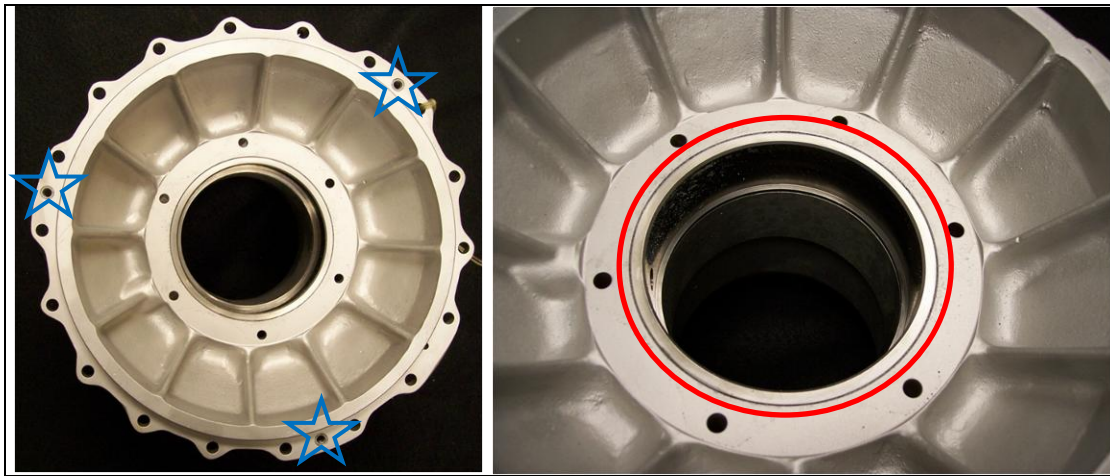
Figure 39. H-64 tail rotor cover contains three helicoil inserts (blue) and one pressed-in bearing liner (red).

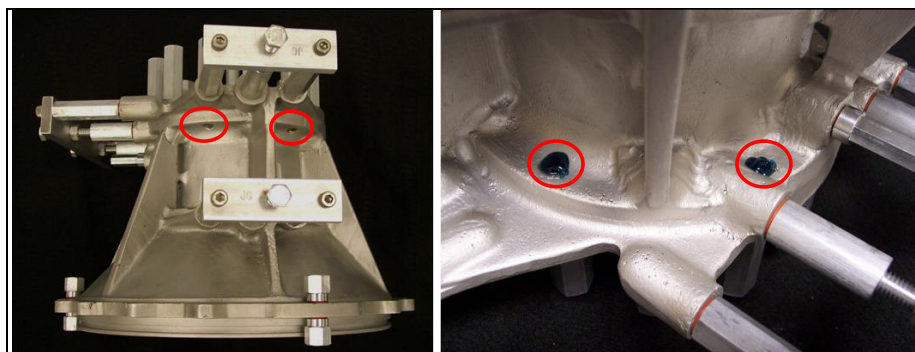
There were studs on the small-diameter opening of the housing that went all the way through flange and broke out of the bottom of the flange, exposing the bottom of the studs (figure 42). The irregular surface in this area eliminated the use of aluminum covers and instead was masked off using the Dymax UV curable maskant applied using a syringe and medium-gauge needle.

Figure 42. Left: location of stud bottoms that are exposed on bottom of the flange.
Right: stud bottoms after filling with Dymax UV maskant.

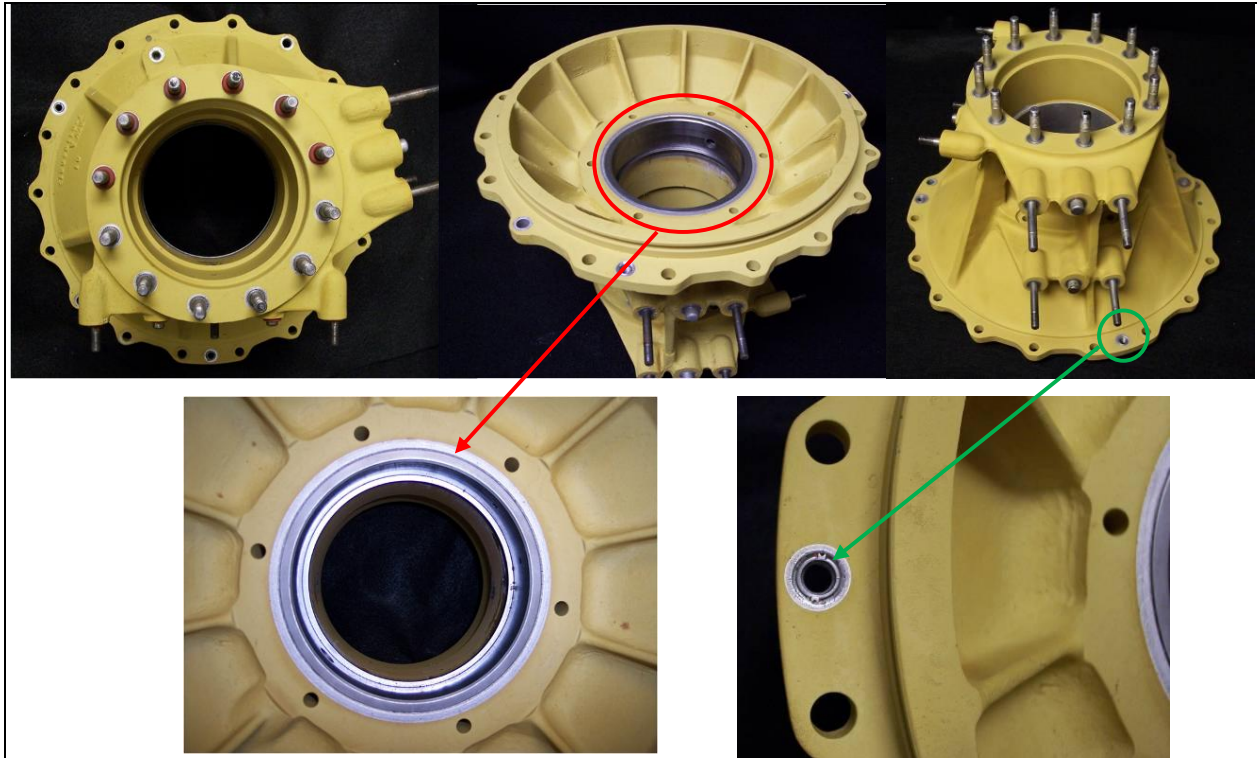
The masked H-64 tail rotor cover was run through the Immersion Tagnite bath using the same conditions that a new tail rotor cover without any mixed metal would be processed in the TAG production line. After the Immersion Tagnite process, the masking was removed, and the parts were inspected. The initial trial was done using the masking protocol developed in section 3.3.3, and there was never a single instance of damage to any mixed metal inserts on this part. However, there was damage to the Tagnite coating during the removal of the steel liner covers. The damage was easily repaired using Brush Tagnite, but the top cover to the steel liner was modified to eliminate the potential for damage during masking removal. Pictures of the tail rotor cover after Tagnite are shown in figures 43 and 44.*

Figure 43. H-64 tail rotor cover after Immersion Tagnite 8500. Lower left: close-up of steel liner bottom after masking removal. Lower right: close-up of helicoid after masking removal.

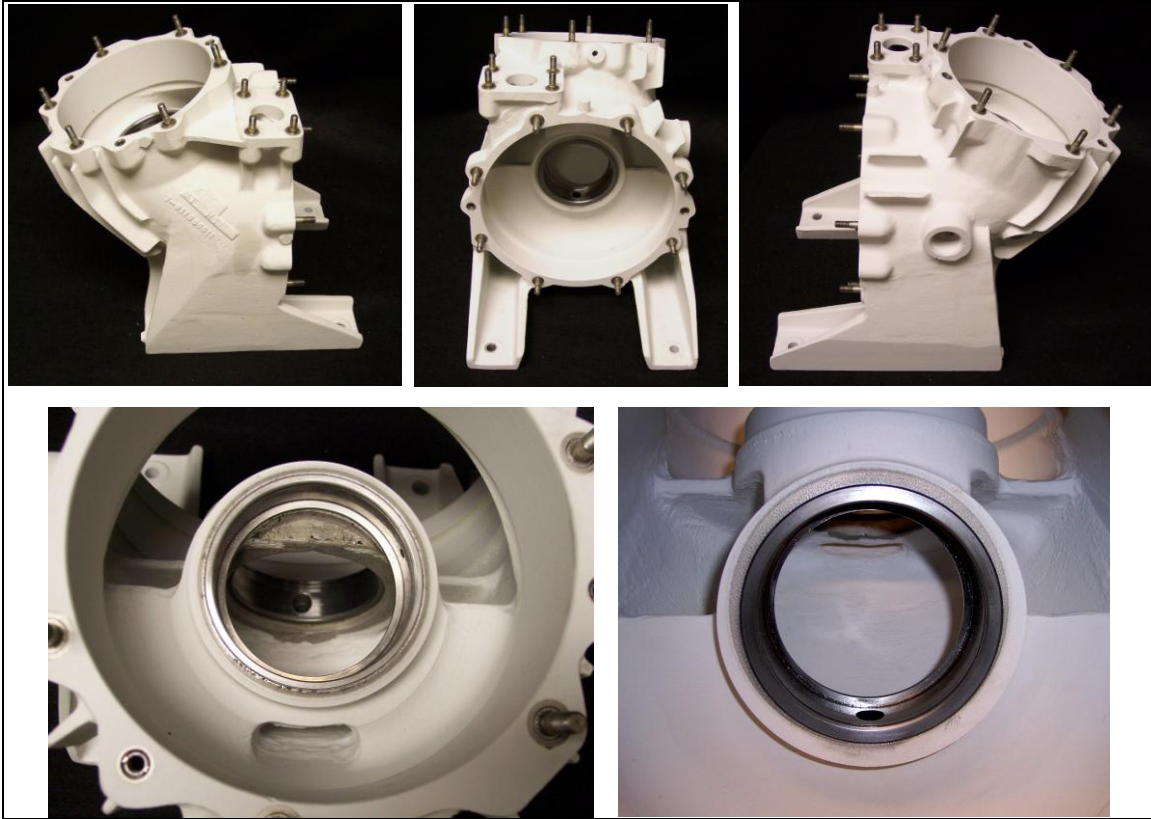
After masking was installed, the part was checked for leaks then run through the Immersion Tagnite 8200 process. The masking was removed and the part was checked for leaks or attack on the mixed metals (figure 54). There was no evidence of leaks or damage. This process was repeated on two other H-64 Intermediate Gearboxes. All three gearboxes were coated without any damage.

Figure 54. H-64 intermediate gearbox after Immersion Tagnite 8200 and removal of masking tools.
 Bottom left: top steel liner after Tagnite. Bottom right: bottom steel liner after Tagnite.

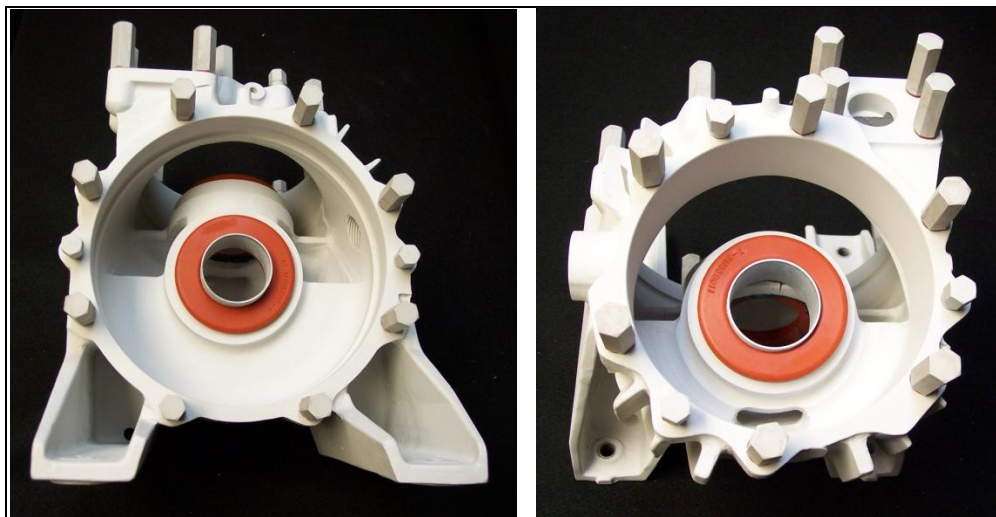
Figure 55. Installation of Acme masking tools on steel liners of H-64 intermediate gearbox.
 Left: masking on bottom steel liner. Right: masking on top steel liner.

Once the steel liner covers were removed after Tagnite, it was immediately evident that the Acme masking tools were not robust enough to survive the Tagnite process. The steel liners had lots of damage caused by a total lack of sealing around the steel (figure 57). After the rust was removed, there was evidence of pitting on the steel, which indicated that the leakage was present during the Tagnite anodize portion of the process; this leakage left the steel liner unusable. The Acme masking was quickly abandoned because of the extensive leaking during the Tagnite process.

During the installation process, TAG personnel discovered that the masking inserts did not protect the bottom of the liners (figure 56). The solution was to attempt to seal the bottom areas of the steel liners with the Dymax UV curable maskant. Inspection of the UV maskant after the Immersion Tagnite process showed that the UV maskant held up well.

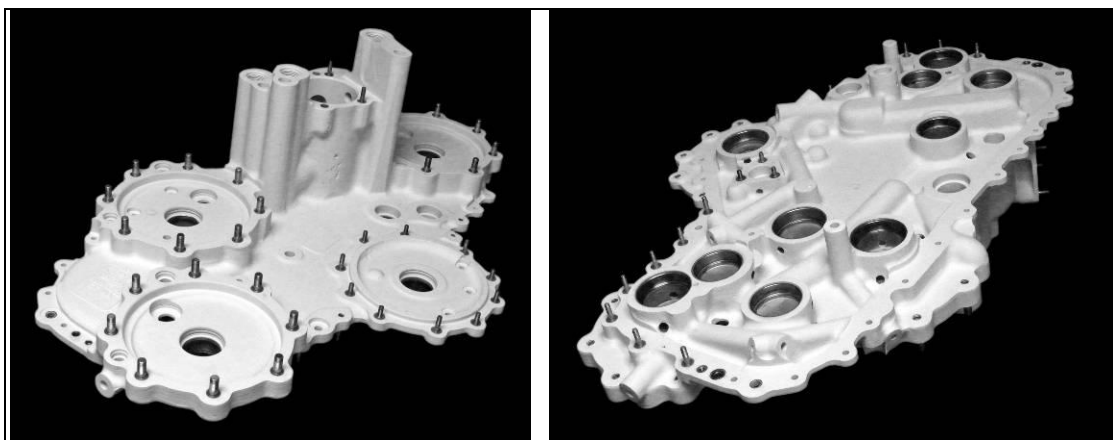
The masked H-47 accessory cover was run through the Immersion Tagnite bath using the same conditions that a new aerospace magnesium casting without any mixed metal would be processed in the TAG production line. After the Immersion Tagnite process, the masking was removed, and the part was inspected (figure 65). There was only one problem seen after the removal of the masking: one of the recessed bearing races had some rust. The rust was easily removed, and the source of the leak was traced to a silicone plug that had fallen out. There was no pitting on the bearing race, which implies that the rust formation occurred after the Tagnite process (figure 66).

Figure 65. H-47 accessory cover after Tagnite and removal of masking tools.

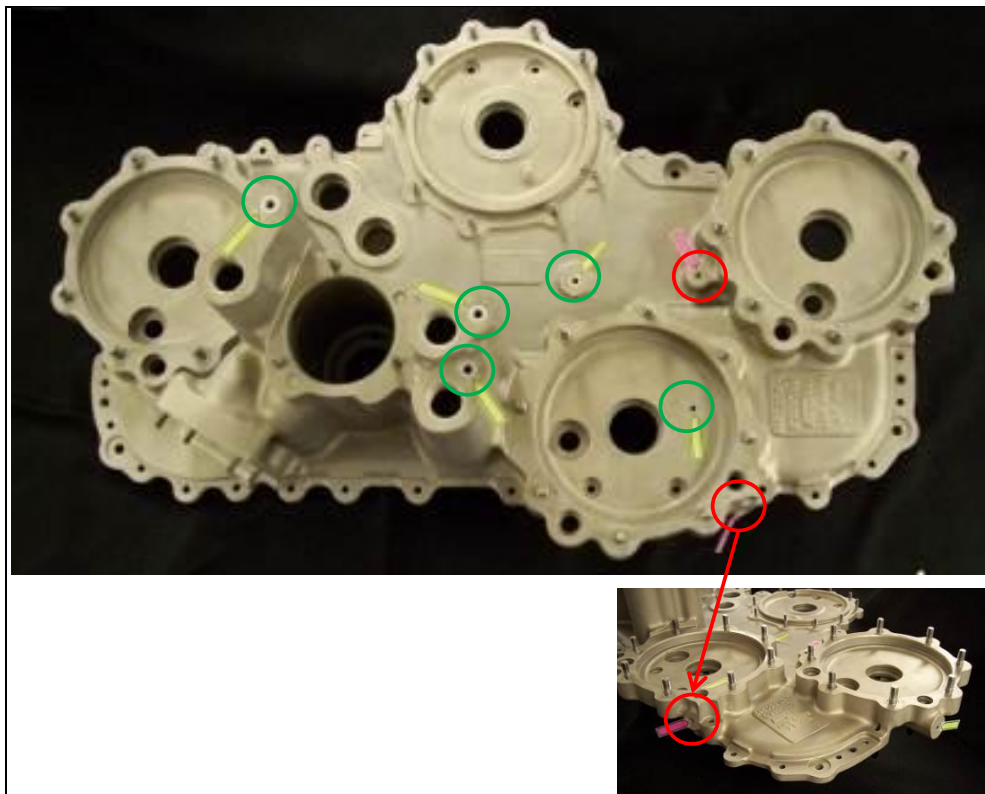
Figure 67. Additional inserts on top of second H-47 accessory cover (view 1): nonmagnetic (green) and magnetic (red).

After masking the additional inserts, the second H-47 accessory cover was coated in the Immersion Tagnite process. An examination of this part after the masking tools were removed showed no evidence of damage to the mixed metals. The extra inserts that were nonmagnetic accepted a Tagnite coating and therefore must be aluminum inserts.

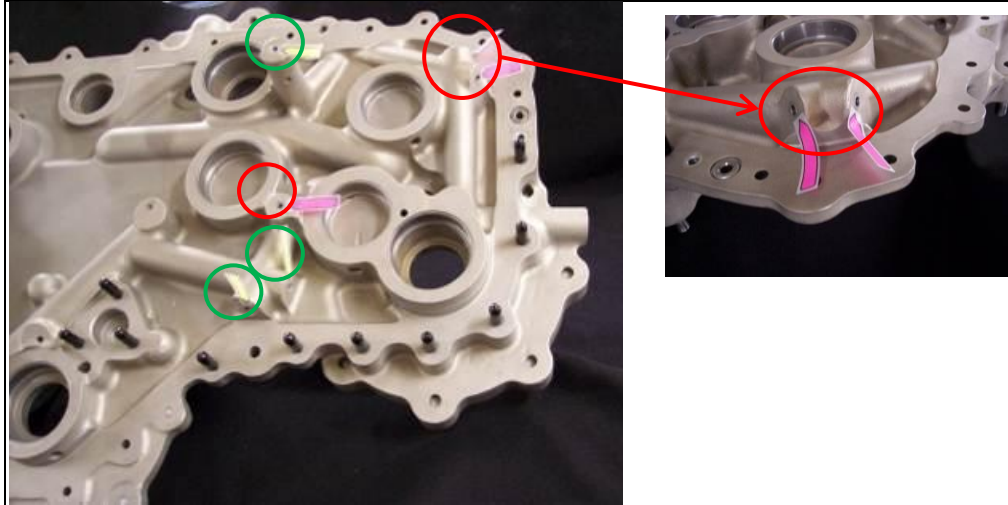
Figure 68. Additional inserts on bottom of second H-47 accessory cover (view 2): nonmagnetic (green) and magnetic (red).

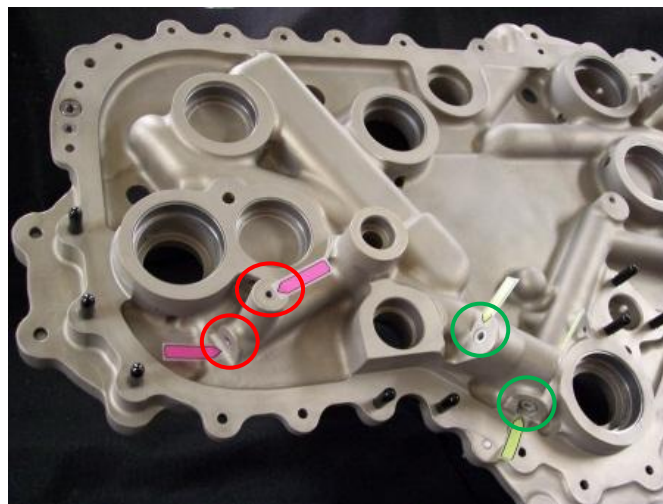
Figure 69. Additional inserts on bottom of second H-47 accessory cover (view 3): nonmagnetic (green) and magnetic (red).
